The British Caving Association  
Minutes of the Equipment and Techniques Committee

**Date:** 8<sup>th</sup> October 2011, 10.40am

This report details the complete series of anchor tests designed to find a replacement for the DMM Eco anchor carried out by the BCA Equipment & Techniques Committee during 2011.

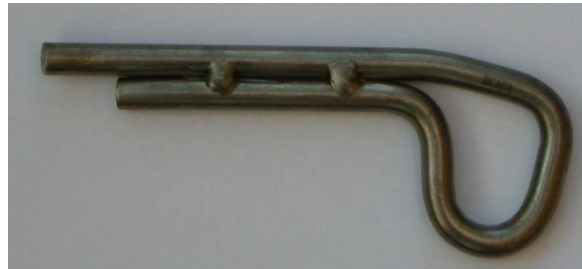
An identical looking product to the DMM anchor was offered by Jonathon Sims who had manufacturing contacts in China. An initial test batch of 200 anchors was acquired and designated "Peco Batch 1". Subsequently, a further production batch of 2000 anchors was ordered designated "Peco anchor Batch 2". As will be observed later in the report, four out of a sample of sixty four Batch 2 Peco anchors suffered catastrophic metallurgical failure below the 25kN threshold.

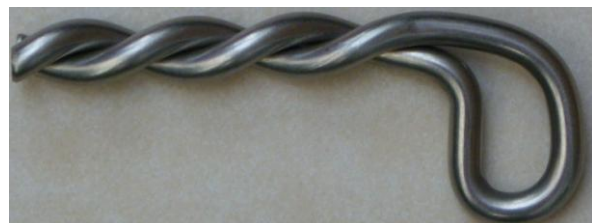
Further research identified another possible alternative supplied by Bolt Products manufactured in Germany to BS EN 959. The major difference with this anchor is that whilst it was still made with 8mm 316 stainless steel bar the two tangs of the anchor were twisted unlike the parallel bars of the Eco and Peco anchors. Another difference was that the eye of the anchor was slightly smaller than the Eco and Peco anchors although it was still of adequate size.

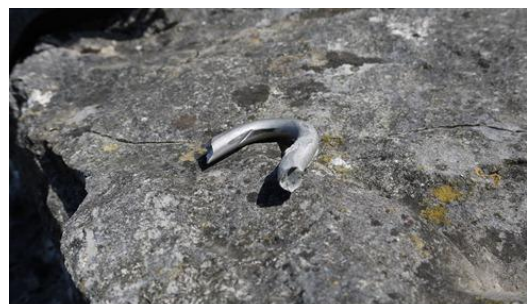
32 Peco anchors were randomly selected from the remainder of the batch and set in structurally solid limestone. As there was only one small area of the test bed where substrate failure occurred the results were generally in line with expectations. However, as in the test at Horseshoe Quarry, two Peco anchors fractured at the lower curvature of the eye. The load at deformation was consistent within a range of 11-15kN giving a mean of 13.28kN. The ultimate failure load, as described above in the tests at Horseshoe Quarry, was within the range 14 - 47kN. Giving a mean peak load force of 33.22kN. Although the fracturing of the substrate did result in some low readings the mode of failure was again consistently the anchor to resin bond except for the two anchors which fractured at the lower curvature of the eye.

Peco anchors No. BCA 0069 and BCA 0153 both fractured at 18kN and 14kN respectively. The main concern is that the lowest fracture load (14kN) would technically make the anchor placement the weak link in the rigging system. The anchor in the photograph was cut to remove it from the placement.

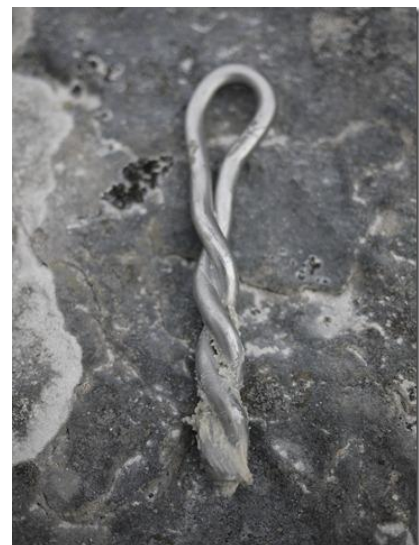
Thirty three Bolt Products anchors were installed in limestone (somebody couldn't count). During the test period it became apparent that the chemical anchor mortar had not thoroughly mixed during application into one of the holes. The peak load to remove this anchor was 36kN. RAWL have been contacted and from the information supplied by us have initiated an investigation. The failure mode is initially similar to a DMM Eco anchor with elongation of the eye towards the direction of the applied load. However, unlike an Eco anchor as it is extracted from the substrate the anchor twists, and along with it the load cell, until the load is released as the anchor suddenly and violently egresses from the resin. The load then gradually increases until the anchor starts to twist and the process is repeated. This behaviour continues until the anchor is extracted from the substrate. Generally the anchor's failure range was consistent; however anchor test numbers 20 and 26 were below 30kN. As the failure mode is anchor to resin bond this is probably due to poor mixing and adhesion of the resin. The deformation range was 18-23kN. The ultimate failure load i.e. the peak load at which the anchor started to egress from the resin or the load required to extract the anchor from the resin, whichever was higher, was within the range 24 - 47kN with a mean of 35.5kN. From the data gathered from these tests it is evident that the anchor and peak load forces are consistent and similar to the DMM Eco and Peco anchors.

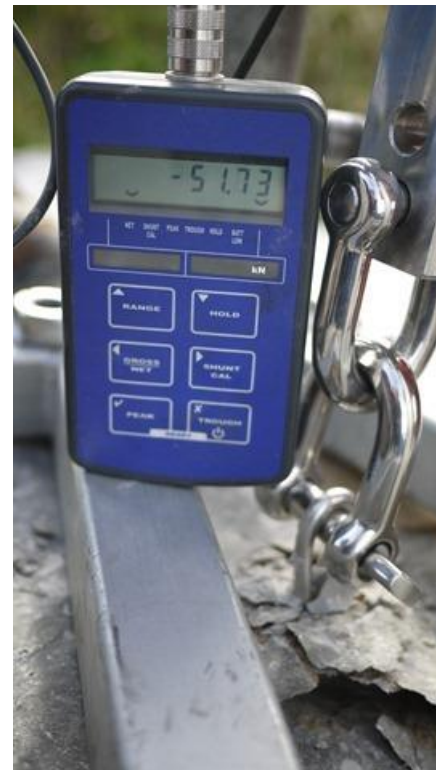
As a consequence of the high pull out loads experienced during these tests the mode of failure changed. Normally, in Eco & Peco anchors, the mode of failure is the anchor to resin bond. The Bolt Products anchors, in the majority of cases, experienced substrate failure and the resin/rock bond with it. On a number of the tests cone fracture and delamination of the substrate occurred followed by the failure of the resin to rock bond. However, as demonstrated in the photo opposite even with delamination the anchor placement still held 51.73kN. With the reduced hole size (16mm) the amount of resin in the placement is also reduced. This causes the resin to fragment and become almost pulverised by the load during extraction of the anchor. This pulverisation is more evident lower down in the placement.

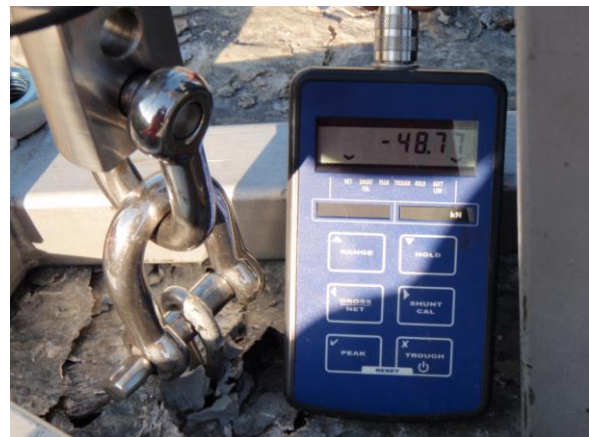
An interesting observation was that the anchors were still holding only a little less than their peak loads when half to two thirds of their length had been extracted. In comparisons between the RAWL R-KER and the Allgrip KMR-RES the inclusion of styrene in the formulation means failure loads are 10kN higher with the Allgrip KMR-RES resin.

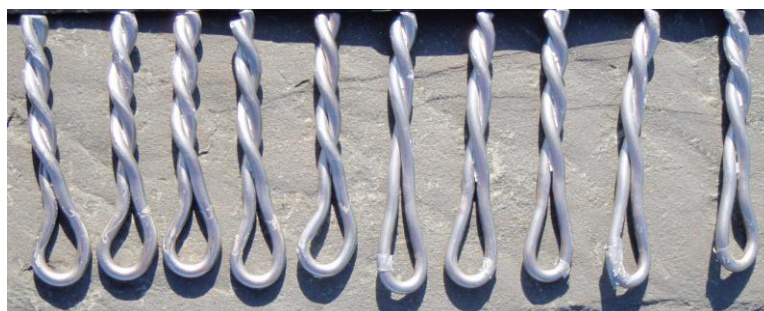
Another interesting observation was that the shank of the Bolt Products anchor unwound and elongated under loads approaching 50kN. (5<sup>th</sup> anchor from right picture below). The deformation loads were similar to the previous test. The ultimate failure load i.e. the peak load at which the anchor started to egress from the resin or the load required to extract the anchor from the resin, or substrate failure, whichever was higher, was within the range 32 - 63kN with a mean of 44.91kN.
