BCA Equipment and Techniques Committee

Meeting held at various locations linked by Webex on 1 December 2016 commencing at 19.45

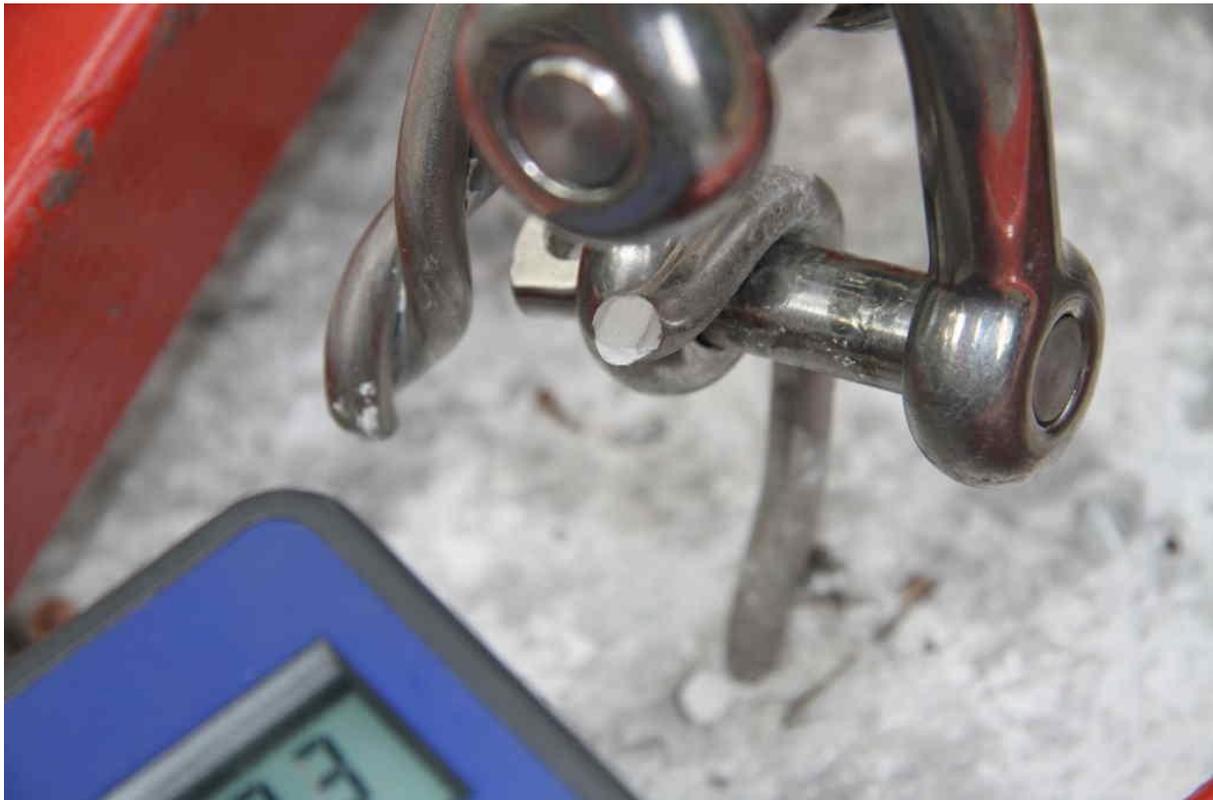
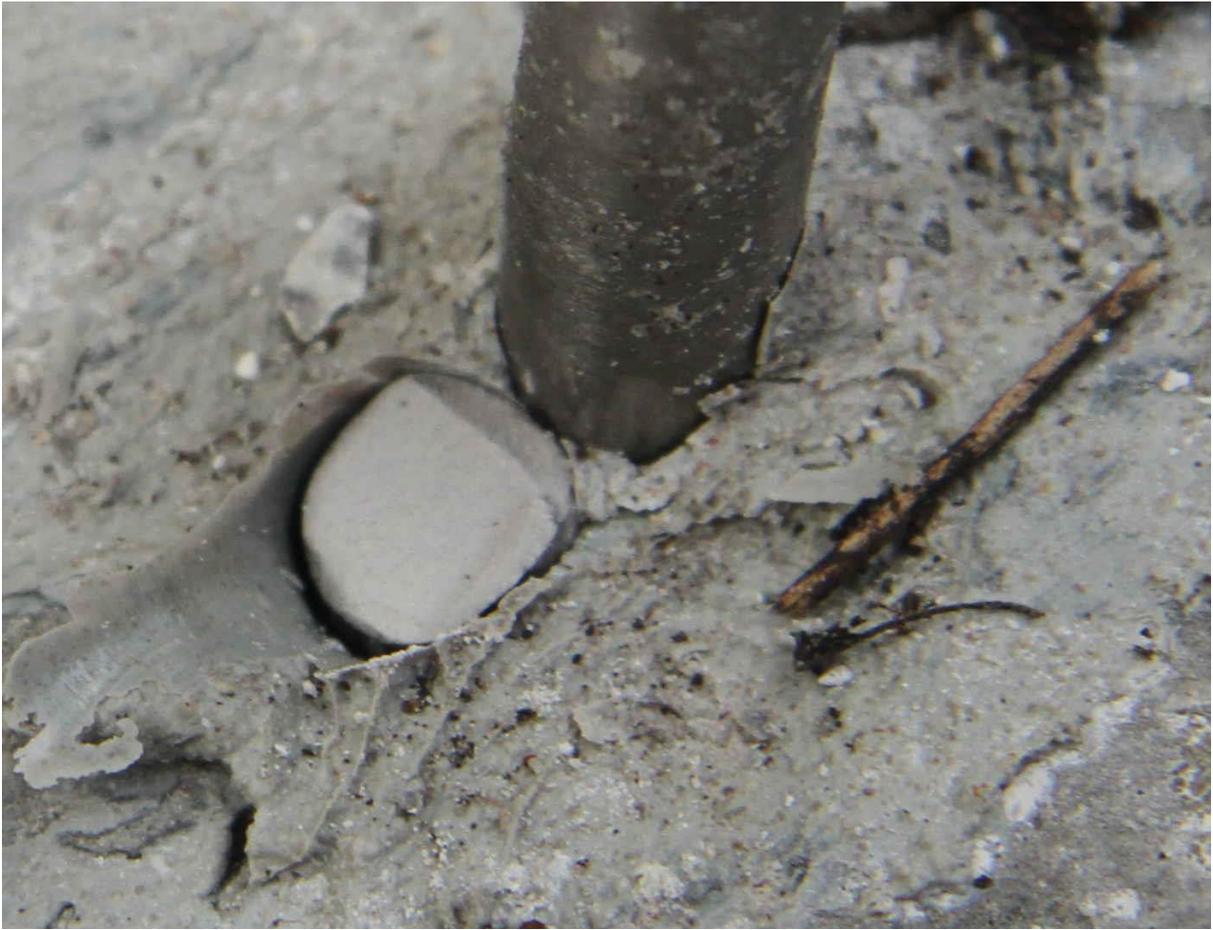
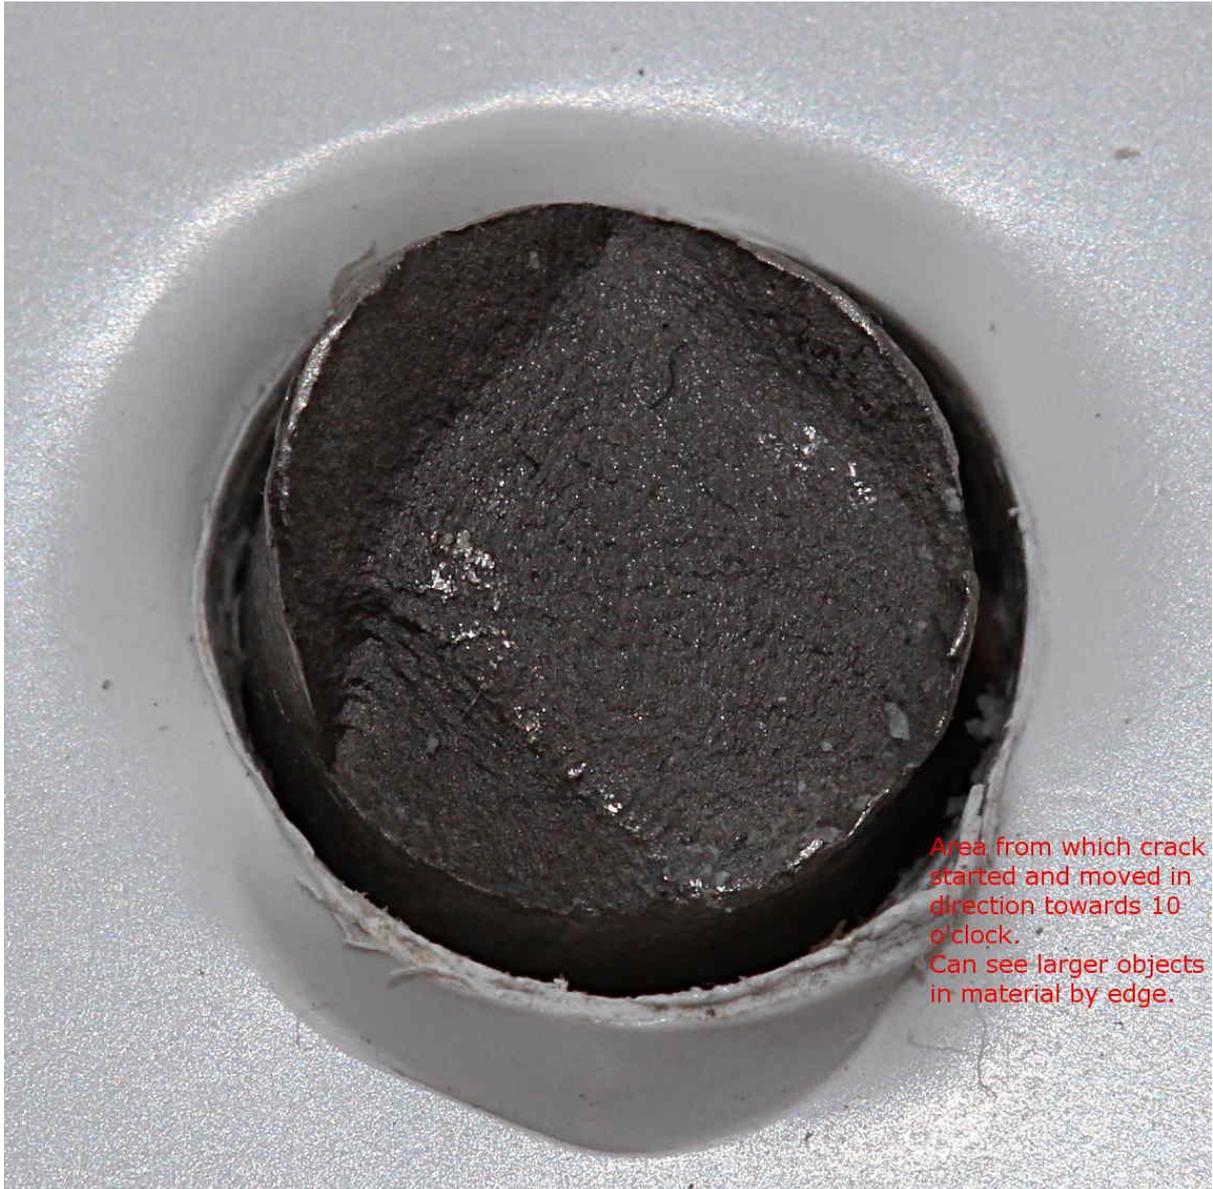
Area from which crack started and moved in direction towards 10 o'clock.
Can see larger objects in material by edge.

I now hold both the head and the shaft of the broken anchor plus the remaining unused titanium anchors.

For information, Bolt Products has supplied me with a couple of his Gr2 titanium anchors for testing. Jim Titt noted in response to sending him the photo titanium 4:

“The photo you attached certainly looks like a material flaw, titanium is very ductile and normally the failure point shows a huge amount of necking, something around 50% of the original diameter and with an extremely rough, torn appearance. It should have held about 40kN anyway!”

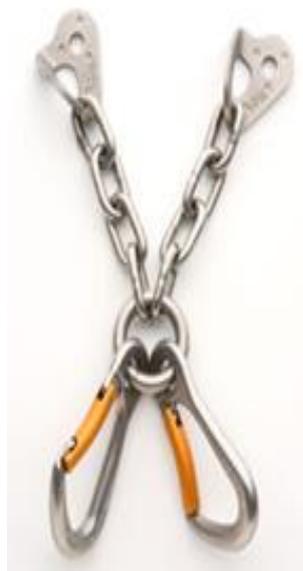
The BMC passed on a report to BCA from UIAA and elsewhere of a problem analysed as being caused by Stress Corrosion Cracking (SCC) in type 304 stainless steel component in an anchor system. The anchor system appears to be sold by Fixe and / or techROCK (it is not clear as to whether one company is a subsidiary of the other) and is labelled as Fixe SS 3/8 Draco V-Anchor, Product ID : 363-3/8 , see alongside.

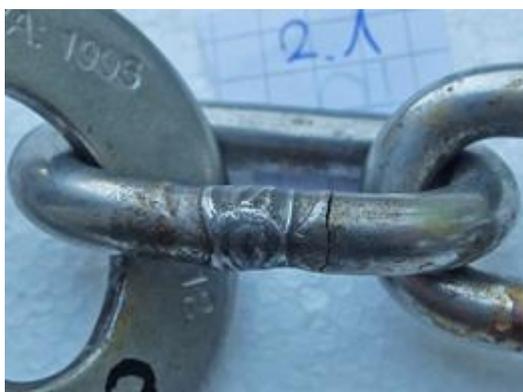
The available information indicates that the problem was first discovered at a climbing wall in Germany and reported by DAV² (German Alpine Club) when a crack had been noticed in the final link, see alongside. A follow up inspection in response to a safety alert identified two more items in total as being affected. It is not clear if these were at the same climbing wall. The report indicates that the items were placed on an external wall, even though Fixe state 'for indoor use'.

techROCK commissioned a report on the items from Fundació CTM Centre Tecnològic, a Spanish technology centre. I await confirmation that the report can be openly circulated. The report indicates three test were conducted: chemical composition, microstructure analysis and fracture analysis. The reported chemical composition indicates the level of carbon and phosphorus exceed the European standard for a type 304 stainless steel. The report goes onto to state that an examination of the microstructure showed features that "are unequivocally characteristics of the Stress Corrosion Cracking (SCC) mechanism". The fracture analysis also provided "another clear indication that the SCC mechanism is the responsible".

The DAV report comments that manual welding of stainless steel can create such problems. I am given to understand that a high carbon level will cause problems with welding and that a low carbon version of 304 (maximum 0.3%) should be used to avoid them.

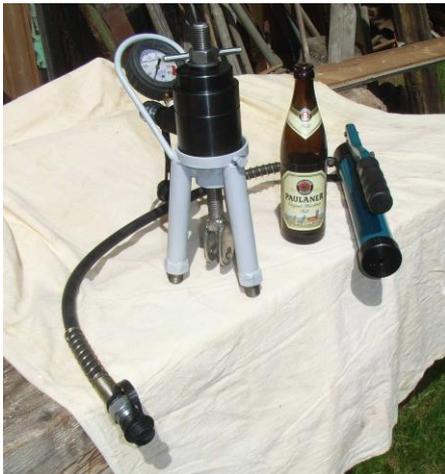
Bolt Products have developed a small hydraulic extractor, see photo attached. We await further details.

Concern has been expressed about being able to remove Bolt Product twisted shaft anchors and then reusing the location with a new anchor. This arises from experience from testing where spalling of the rock around the hole occurs in a substantial fraction of BP anchors removed during testing.

This concern may be unwarranted since the testing process used a puller which is designed to locate the reaction force into the rock at some distance from the anchor. Anchor extraction would use a smaller device which placed the reaction force back into the rock surrounding the hole, thus much reducing the possibility of spalling, see <http://www.resinanchor.co.uk/5.html> . However it seems prudent to look at other ways in removing anchors as well as reusing the location.
